Manhole Inspection Summary

Manhole # S27CC_035MH

Insp Date: **9/21/09 3:23 PM**

Location Address: **IN FIELD ACROSS FROM LANVALE ST** Cross Street: **PENNSYLVANIA AVE**

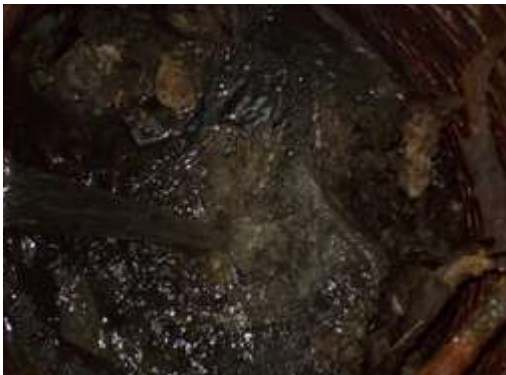
Defect 2

Surcharge ☒ **Evidence Of Surcharge** Depth: **7.4** (ft.) ☐ Active Surcharge Present

ACTIVE SURCHARGE

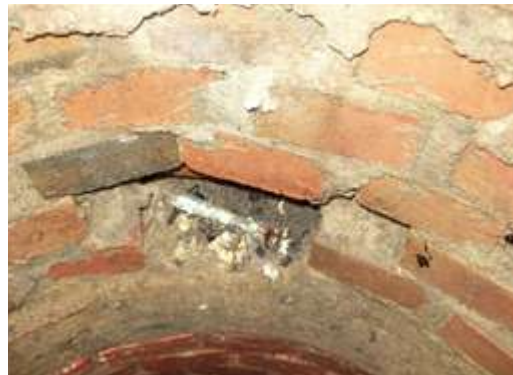
Defect 1

Condition: ☐ Sound ☐ Cracked ☐ Root Intrusion ☒ **Loose Brick** ☐ Deteriorated

LOOSE BRICK IN CHIMNEY

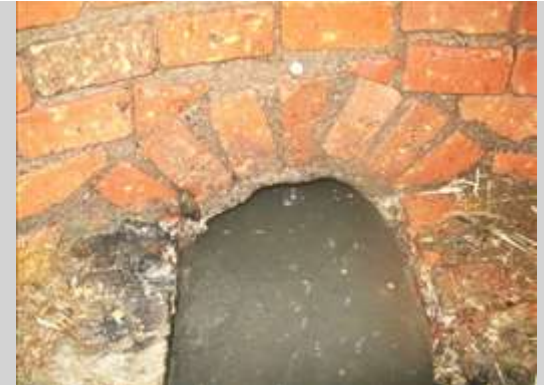
12 O'Clock Outflow

8 in. Circular Gravity Sewer
Pipe Out @ 12 O'Clock

Deposits: ☐ None ☐ Mud ☒ **Sludgy** ☒ **Debris** ☒ **Grease**

Silt Depth: **3** (in.) Deposits Extent: **Medium**

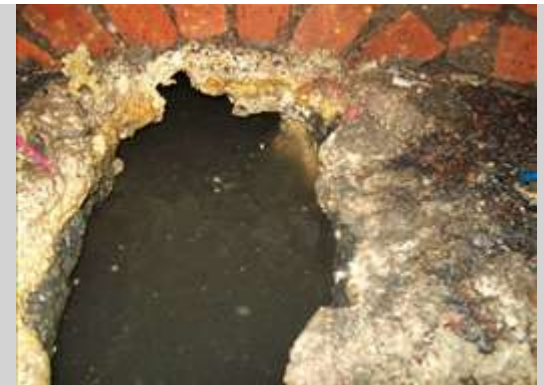
3 O'Clock Inflow

8 in. Circular Gravity Sewer
Pipe In @ 3 O'Clock

Deposits: ☐ None ☐ Mud ☒ **Sludgy** ☒ **Debris** ☒ **Grease**

Silt Depth: **3** (in.) Deposits Extent: **Medium**

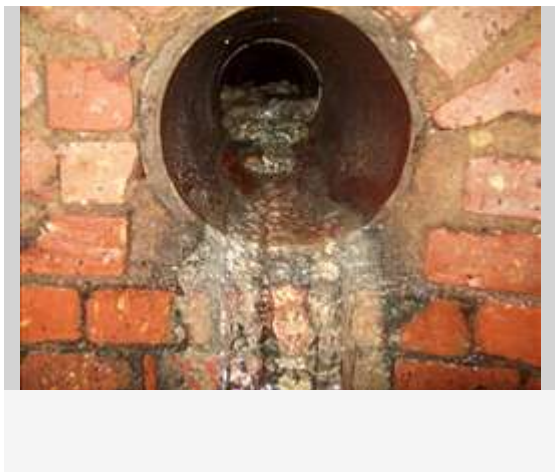
6 O'Clock Inflow

8 in. Circular Gravity Sewer
Pipe In @ 6 O'Clock

Pipe Height: (in.) Direct
Pipe Material: **Clay** ☐ Pipe Lined
Invert Depth: **11.57** (ft.) Flow Characteristics: **Slow**
Deposits: ☐ None ☐ Mud ☒ **Sludge** ☒ **Debris** ☒ **Grease**
Silt Depth: **3** (in.) Deposits Extent: **Medium**
Infiltration: **None** Pipe Seal Cond: **Sound**

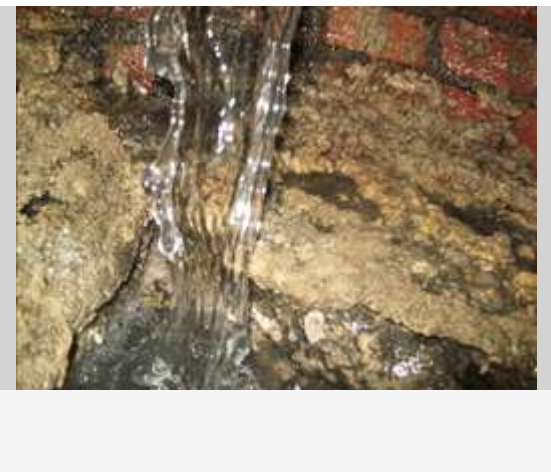
Drop In @ 6 O'Clock

Drop: Inside	Direct
Angled:	Reading: (ft.)
	Inv Depth: 13.62 (ft.)
Drop Condition: Clogged
